Grillo G85-G107 PTO Coupler / Ball and Spring Replacement / Addition of tension shim

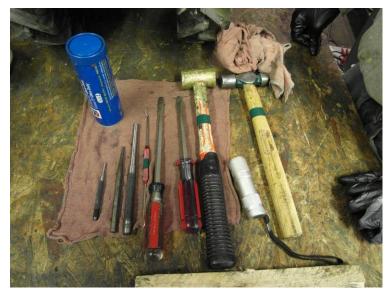
Tools needed for job (3/16" pin punch, screwdrivers, hammer [brass or steel], pick, grease) (you don't need the flashlight...)

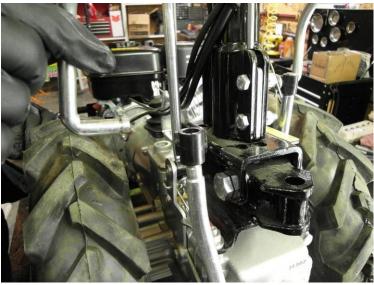
1) Remove pin & washer, Slide PTO control rod sideways out of plastic joint. Then, lift plastic joint off lower shift lever.

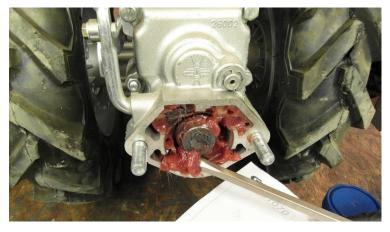
2) With implement / female Quick coupling removed from tractor, clean some grease out of PTO area so you can see inside.

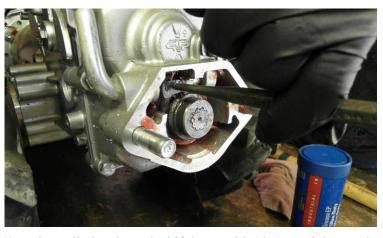
3) Drive roll pins through shift lever with 3/16" straight punch. The pins will fall through the other side into a recess in the housing, and can be easily retrieved after linkage is removed.

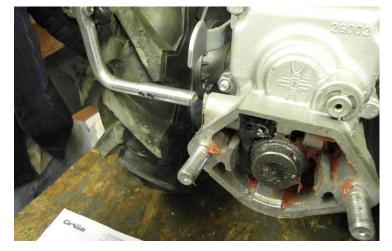
4) Slide outer PTO lever out of housing.

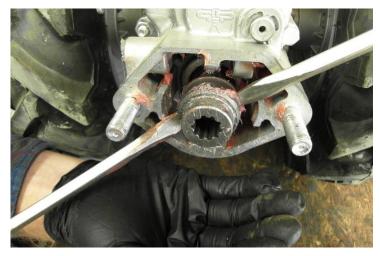
6) Pop PTO coupler off shaft with a couple of screwdrivers. Watch out for the detent ball & spring...the ball will pop out of the shaft when the coupler is removed.

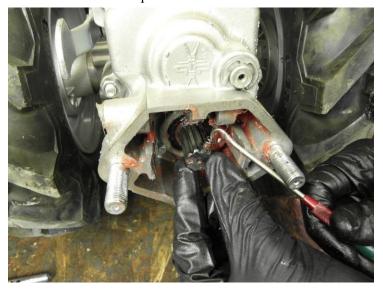
8) Remove old spring from hole in side of shaft with pick, little screwdriver, piece of wire, etc.

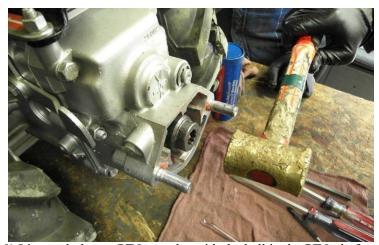
10) Line up holes on PTO coupler with the ball in the PTO shaft, press the coupler into place so that the taper on the rear of the coupler holds the ball down into place, and while pressing in firmly, tap the coupler onto the shaft fully with a soft hammer or piece of wood. (this picture was actually taken a second too late...the coupler is already back on the shaft to the first hole. This is a tricky procedure, and it may take a few tries to get it on.)

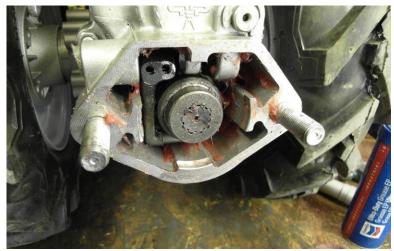
11) Reinstall inner PTO shift lever into PTO flange, aligning bottom "bar" of the lever inside the slot on the coupler.

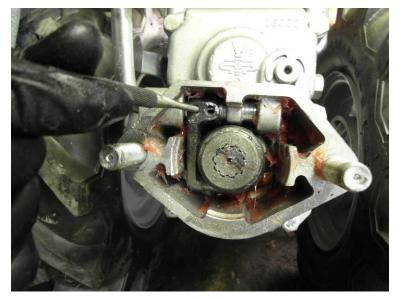
12) Install outer PTO shift lever through housing and align holes on both outer and inner levers with straight punch.

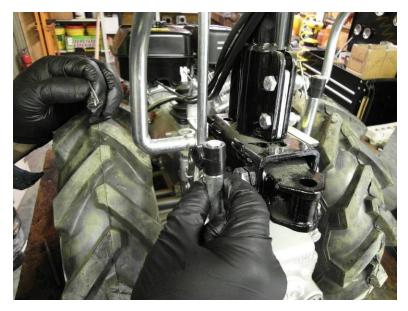
14) Reconnect outer shift levers at joint, sliding joint down onto the lower lever first, then the control rod into the joint. Re-install washer and then R-pin to secure.

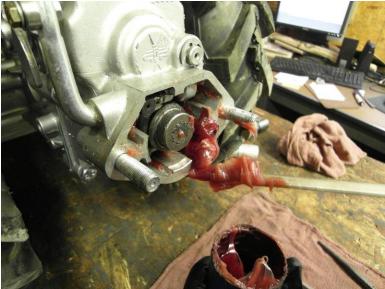
15) Re-pack PTO flange with general-purpose lubricating grease. (this can be done with a grease gun)
